GRADUATE AERONAUTICAL LABORATORIES CALIFORNIA INSTITUTE OF TECHNOLOGY

An Experimental Investigation of the Failure of a Stepped Composite Plate

Thesis by
Steven C. Gortsema

Aeronautical Engineer

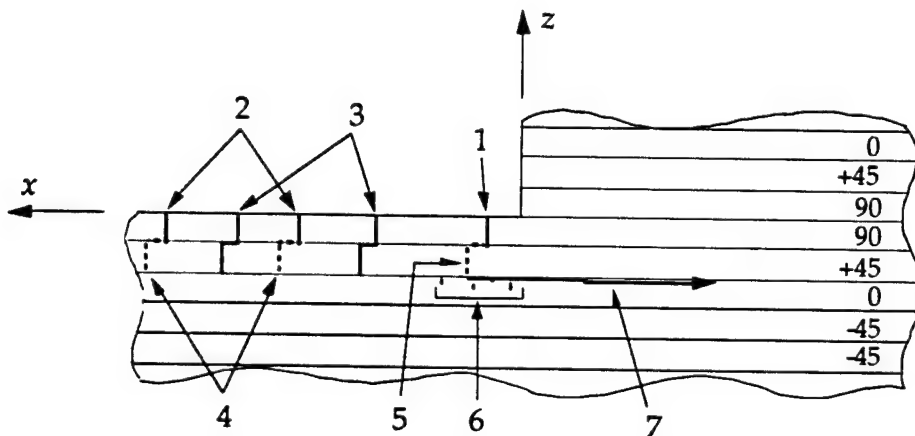
Figure 9. Damage development on the positive edge.**

1. $\{M \approx 39\% \text{ of } M_{fp}\}$ The 90° ply (plate interface ply) cracks near the step, usually at values of x between 1 and $1\frac{1}{2}t$, where t is the ply thickness (Figure 10a).

matrix cracks in the 90° and 45° plies intersect near the positive edge, the cracks viewed on the surface often jogged away from the step (in the $+x$ direction) (Figure 9).

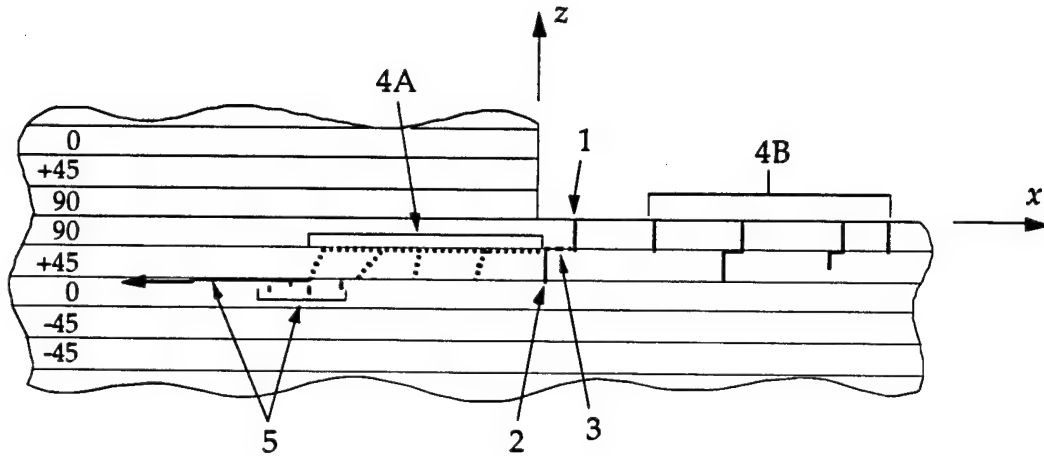
Figure 11. Damage development on the negative edge.

1. $\{M \approx 41\% \text{ of } M_{fn}, \text{ where } M_{fn} \text{ is the moment loading at ultimate failure for this specimen}\}$ The first damage seen on the negative edge is also the cracking of the 90° ply near the step (Figure 12a).^{††} This crack, and the others which later develop in the 90° ply, cross the entire width of the specimen.*

- (i) This process usually begins with the interface crack propagating farther away from the step and then turning into the 45° ply. However, sometimes the crack in the 45° ply appears before the extension of the interface crack, as shown by the crack near the bottom of Figure 12c. In Figure 12d, the same interface crack propagated farther along the specimen before turning into the 45° ply.
- (ii) Next, the 45° ply crack farthest from the step grows almost all the way across the ply. Then the delamination crack (interface crack) grows along the interface, and turns into the 45° ply again. This process is repeated several times as the load is increased (Figure 12e, "4A" in Figure 11).

As this delamination process starts to occur, additional cracking begins to develop on the plate edge on the other side of the step where x is greater than zero ("4B" in Figure 11). Some of these new cracks cross both the 90° and 45° plies, but the damage by the corner appears the most severe throughout the entire test when viewing the negative edge.

The intersection of the high-stress regions caused by all of the above mechanisms is in a small area near the tip of the 90° ply crack within one ply thickness of the negative edge. Therefore, when the load becomes high enough, the next type of damage to appear is cracking in the 45° ply in this region. Because of the variation in parameters such as fiber position and fiber volume fraction, the area where the stresses first exceed the fracture level is not always right *at* the negative edge. If this area happens to be just inside the specimen, then the matrix crack in the 45° ply intersects the edge at an x position slightly less than that of the 90° ply crack. This observation explains why many of the cracks viewed on the negative edge jogged toward the step as they travelled from the 90° ply to the 45° ply (Figure 11). Similarly, when

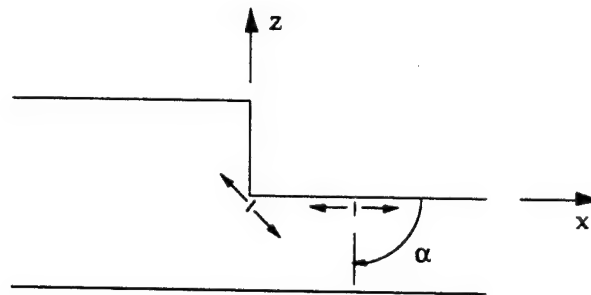
Figure 13. Directions of maximum normal stress calculated from the results of Kubr's numerical study.

run straight across the plies, regardless of how close they are to the corner. This observation seems to contradict the numerical, asymptotic solution by Kubr, which would indicate that the lines of principal stress in the plate interface ply directly below the step (-z direction) are 45° different from the lines of principal stress in the same ply out away from the step (+x direction) (Figure 13).

These two features indicate that the failure process is not entirely driven by the nature of the "analytical stress singularity," as may be widely believed. It is true that failure does initiate *near* the corner, but since it is not right *at* the corner, one can deduce that the precise structure of the geometry and of the singularity does not completely govern failure initiation. It seems that for composite materials, the local variation in material parameters, combined with the inherent ability of composites to redistribute loads away from regions of high stress, often prevents the singularity from dominating the failure mechanism. This suggests that in modeling a stepped composite plate, it may not be wise to spend a lot of resources on developing a precise

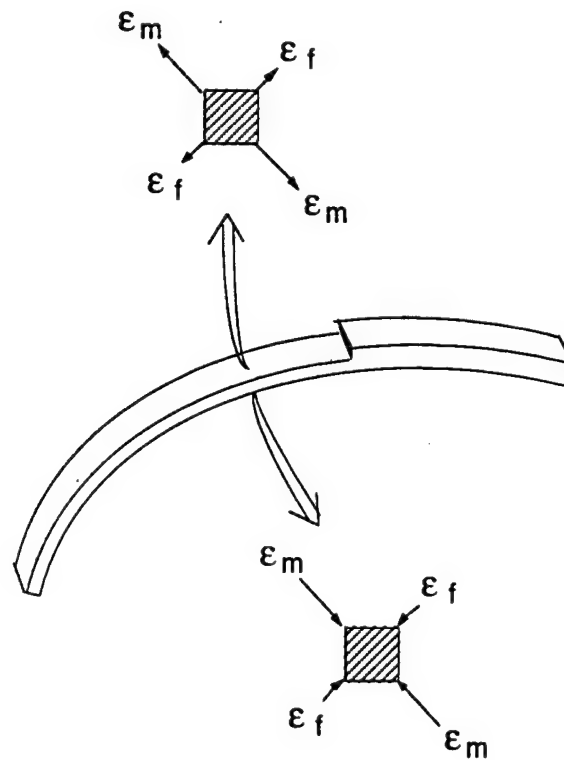
Figure 14. Specimen twist mechanism.

One other effect which contributes to the location of maximum stress is the twisting of the specimen. This effect is mainly caused by the 45° plies near the surface of the plate, as shown in Figure 14. For a given axial stress, there is a larger strain transverse to the fibers than parallel to them. This skews the axis about which the specimen bends, giving a smaller radius of curvature, and therefore a higher bending stress, along the negative edge.

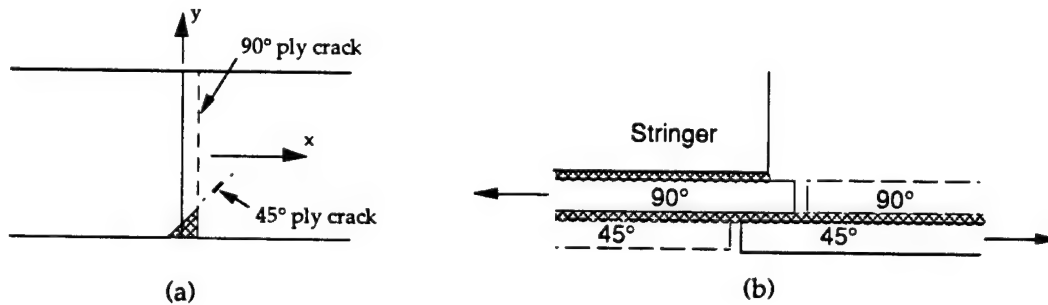
Figure 15. Region of high shear stress.
(a) plan view (b) negative-edge view.

When a crack in the 45° ply forms near the end of the step by the negative edge, a triangular region of the interface is isolated (Figure 15a), causing it to be loaded with a very high shear stress. This is most easily seen by considering a force-balance diagram of the cracked portion of the specimen near the negative edge (Figure 15b):

The plies are under a tensile loading away from the crack because of the bending. Since both the 90° and 45° plies are unable to support a tensile stress near the transverse cracks, the entire force is transferred through the small overlapping region of the interface. This makes the shear stress in this area very high, causing the interface to fracture. Therefore, for this lay-up, the damage development indicates that delamination initiation is caused by interlaminar shear stress.* Although this feature appears to be a direct result

The above discussion on delamination initiation for lay-up case 1 has focused on finite-width specimens, where the free edge provides one of the borders for the region of high shear stress shown in Figure 15. However, one must realize that the same mechanisms also apply to wide plates, e.g., stringer-reinforced skin panels. In situations where free-edge effects are not important, the delamination will still start by one of the areas where the 45° and 90° ply cracks cross. This is so because the tensile stress in the plies is approximately constant across the width of the specimen (neglecting twist), and the area per unit width in which the tensile stress can be transferred from one ply to the other is smallest near the crack intersection, causing the shear stress to be highest there.

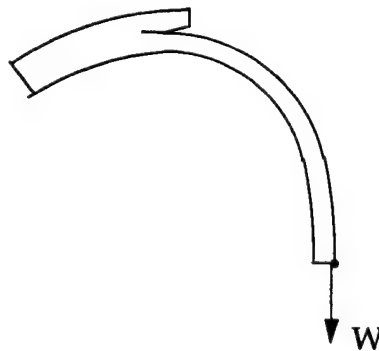
Figure 17. Delamination caused by different bending stiffnesses.

- (ii) The discontinuity in bending stiffness also contributes to this opening stress since the plate tends to deflect much more easily than the plate-stringer combination (Figure 17).

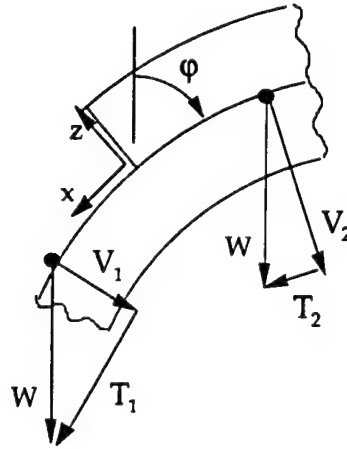
Figure 18. The relation of beam shear force to delamination tip position.

One difficulty in partially attributing the delamination propagation to beam shear force is that in a two-dimensional drawing, this seems to be an unstable process. Figure 18 implies that as the delamination crack tip moves in the $-x$ direction, the shear force at the crack tip increases if the load angle, ϕ , is less than 90° . This apparent instability seems to contradict the negative-

edge observations, which indicated that the early stages of delamination were a stable process.

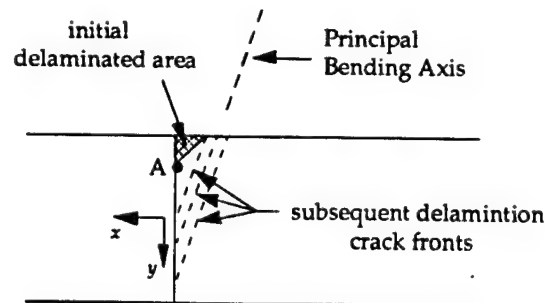
Figure 19. Plan view of delamination crack advance.

However, when viewing the delamination crack front in plan view (Figure 19), one realizes that the amount of new surface area per unit crack advance increases as the delamination grows across the specimen. In terms of the Griffith criterion for crack advance, this increases the total energy required for each subsequent unit of crack propagation. Therefore, since the required energy is increasing as the shear force is increasing, it is no longer clear whether the process is unstable.

- (i) After the initial 45° triangular delamination crack forms, the highest stress is at point A in Figure 19.
- (ii) The part of the crack front by point A then propagates until the crack front is parallel to the principal bending axis.
- (iii) The crack front then advances uniformly until it reaches the positive edge of the specimen.

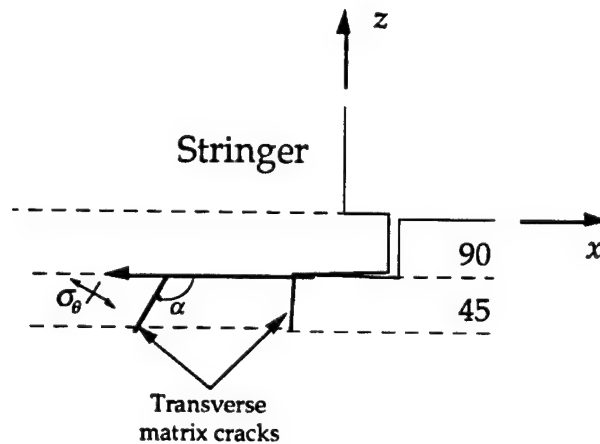
Figure 21. Cracking in the 45° ply on the $-x$ side of the step.

Referring to Figure 21, after the delamination crack travels along the interface, away from the previous crack in the 45° ply, the tensile stress below the crack tip increases. This causes the circumferential stress at the delamination tip, σ_θ , to increase in directions below the interface. When σ_θ in some direction below the interface is significantly larger than σ_θ on the

interface, the crack kinks into the 45° ply.* When the crack impinges on the 0° ply, the composite's resistance to fracture, e.g., $\sigma_{\theta}|_{crit}$, becomes much larger, causing the crack to arrest. Now that there is a free surface crossing the 45° ply by the delamination crack tip, the ratio S (defined in the footnote) is maximum along the interface. Therefore, when the load is high enough, the crack propagates along the interface, and the process repeats.

terms of the ratio $S \equiv \frac{\sigma_{\theta}}{\sigma_{\theta}|_{crit}}$. When S for some direction below the interface becomes larger than S on the interface (and larger than 1), the crack kinks in the direction of S_{max} . As shown in Figure 21, the angle, α , at which the crack crosses the 45° ply in the region on the -x side of the step is not always 90°, as it was on the +x side.

The above explanation for the kinking of the interface crack is also supported by the orientation and position of the cracks in the 45° ply. As the delamination grows in the $-x$ direction, cracks in the 45° ply which occur a larger distance beyond the previous 45° ply crack tend to cross the ply at a crack angle, α , closer to 90°. For example, in Figure 21, if the distance between the two transverse matrix cracks in the 45° ply is large, then it is likely that the second crack (the one on the left) will be oriented at a crack angle closer to 90°. However, if the distance between the two cracks is small, then α is likely to be closer to 180°. This fracture behavior is reasonable since the tensile stress that is due to bending is higher in areas farther from the 45° ply cracks.[†] This fact maximizes σ_θ at a smaller angle (closer to 90°) when the delamination crack tip is in one of these areas of higher bending stress.

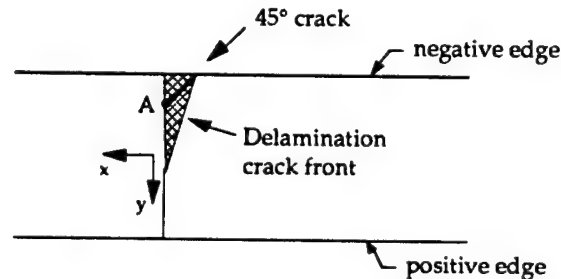
Figure 22. Plan view of delaminated area.

It should be pointed out that this explanation can be modified to account for the occasions when the delamination crack resumes its propagation along the interface before the crack in the 45° ply reaches the 0° ply. In order to understand this situation, the reader must again be reminded of the three-dimensional shape of the delamination crack. Since the crack front lines up with the principal bending axis and not with the 45° fibers, the apparent kinking of the delamination crack as seen from the negative edge leaves most of the delamination crack front unchanged (Figure 22):

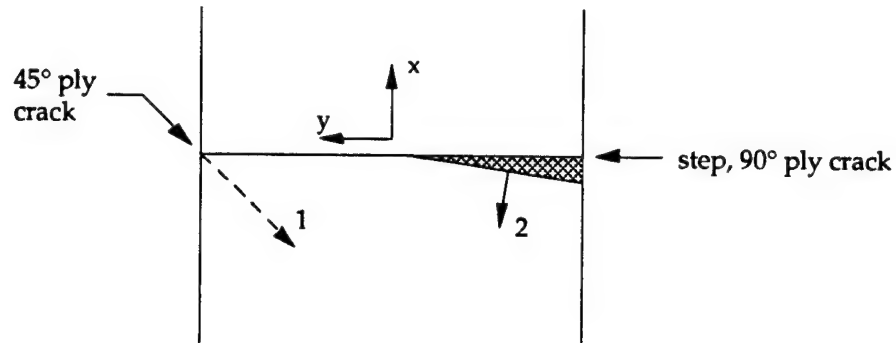
Figure 23. Contributions to "mode III" displacement.

When the local loading by the intersection of the corner crack and the positive edge reaches a critical value, this crack, too, extends across the 45° ply. After the load is raised slightly higher, a substantial increase in mode III displacement of the crack is observed. The perceived mode III displacement is

the y component of the 45° ply crack-opening displacement, which is believed to have two sources (Figure 23):

First, as the crack in the 45° ply propagates into the specimen, the crack-opening displacement at the free edge increases. Second, as the 90/45 delamination spreads across the specimen, the curvature of the 45° ply increases as the portion of the plate below the delamination ($-z$ direction) peels away from the stringer and 90° ply above the delamination. This increase in curvature causes the tensile stress in the 45° ply to increase ahead of the delamination tip as well as behind it, thus increasing the opening stress and crack-opening displacement of the 45° ply crack near the corner. This second contribution is believed to be the cause of the damage noise which preceded the perceived mode III displacement.

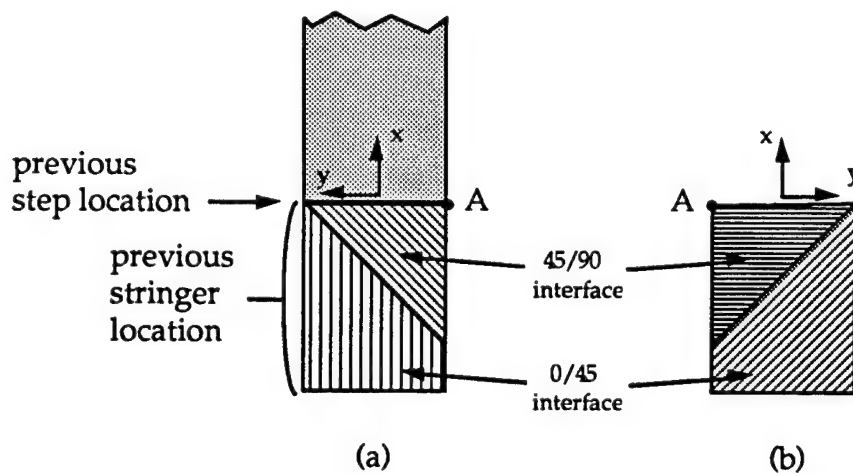
Figure 24. Fracture surface of case 1 and 4 specimens. (a) Plate side of the fracture surface. (b) Stringer side of the fracture surface.

The details of the 45/0 delamination are most easily recognized by analyzing the fracture surface. In all of the case 1 and 4 specimens, the fracture surface can be represented by Figure 24.

One may wonder why the final separation crack of the 45° ply always coincides with the intersection of the step and the positive edge. After all, the 45/0 delamination often begins much closer to point A.* This difference is best understood by considering the alternatives to the fracture surface of

Figure 24. Since the local loading increases as one travels toward the y axis from the $+x$ side, it is clear that the final separation crack in the 90° ply will be located by the step. Therefore, we need only consider the alternative positions of the 45° ply separation, as shown in Figure 25:

Also, a significant opening stress in this region due to bending would require a sizable change in bending stiffness between the portion of the plate with the 90° plate interface ply and the portion without it. This also does not occur. Therefore, the stress levels needed to delaminate the 90/45 interface on the +x side of the step do not exist. This makes it clear why the fracture surface consistently appeared as shown in Figure 24.

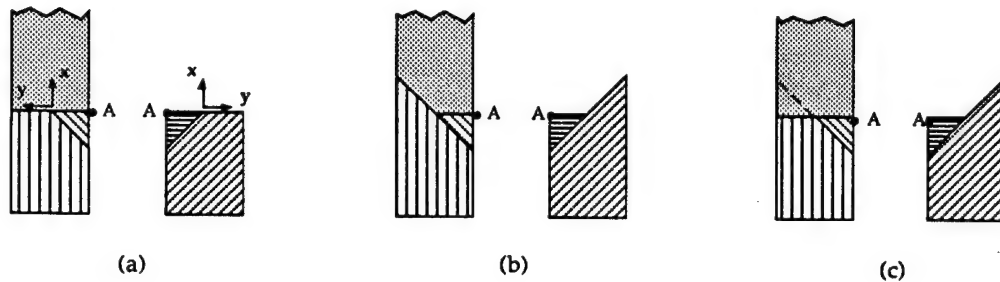
Figure 25. Alternative fracture surfaces.

The 90° plate interface ply prevents the 45° ply below it from separating freely at values of x greater than that for the 90° crack. One way in which the 45° ply can peel away from the plate differently than shown in Figure 24 is if some of the fibers break where they cross the 90° ply crack (Figure 25a). Another method that allows this to be achieved requires the 90° fibers in the plate interface ply to break where they cross the 45° ply crack (Figure 25b). One other way is for the $90/45$ and the $45/0$ interfaces to delaminate by the triangular portion of the 45° ply protruding above the step (Figure 25c). This will then allow the 45° ply to be pulled out from underneath the 90° ply when it separates.

Since the first two alternative mechanisms shown in Figure 25 require large numbers of fibers to fracture and separate, it is easy to see on physical grounds why the observed fracture surface requires less energy. For the surface of Figure 24 to be created, the $90/45$ delamination crack must continue

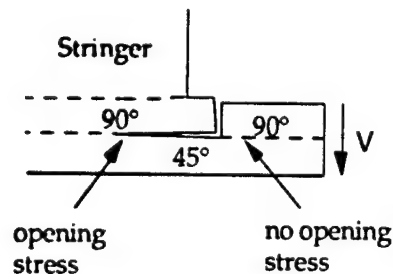
Figure 26. The contribution of beam shear force to the opening stress on the $90/45$ interface.

Even though the third mechanism which would allow the 45° ply to separate at positive values of x usually involves less total delamination area, it doesn't occur because the stresses are much less where x is positive. In particular, the mode I opening stress for the $90/45$ interface is almost negligible on the $+x$ side of the 90° separation crack. Neither of the mechanisms which contribute to delamination propagation have a significant effect on the peel stress in this region. As illustrated in Figure 26, the existence of a significant interlaminar tensile stress caused by beam shear force requires the 90° ply to move in the opposite direction as the 45° ply does. This is not the case on the $+x$ side of the 90° separation crack.

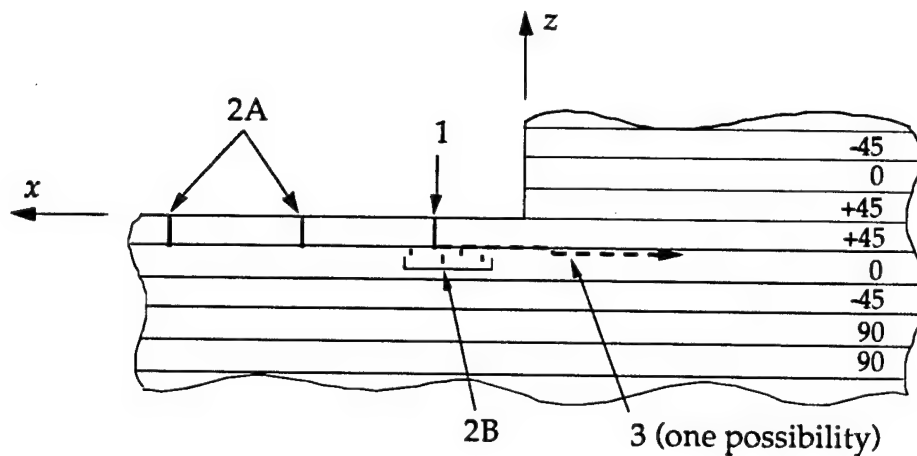
Figure 27. Damage development on the positive edge.

As the load angle, ϕ , was increased during the test, the damage progressed through various stages when viewing the positive edge. Each of these stages is described below and is illustrated in Figure 27.

1. $\{M \approx 77\% \text{ of } M_{fp}\}$ Damage is normally heard before the first crack is seen, indicating that damage does not initiate on the positive edge. However, when the first crack does reach the edge, it is usually a few ply thicknesses away from the corner (Figure 28a).
2. $\{M \approx 93\% \text{ of } M_{fp}\}$ As the load angle increases, more cracking is seen farther away from the step at larger values of x (shown by "2A" in Figure 27). However, not nearly so many cracks develop on the edges of the case 2 specimens as did for cases 1 and 4. When viewing the positive edge of a case 2 specimen, only 2 or 3 cracks are seen before failure, compared with over a dozen cracks in the case 1 and 4 tests.

At approximately the same load, 0° fiber fractures are often observed ahead of the 45° ply crack nearest the corner (shown by "2B" in Figure 27). In some cases this crack even turns and begins to propagate stably in the $-x$ direction along the $45/0$ interface (Figure 28b).

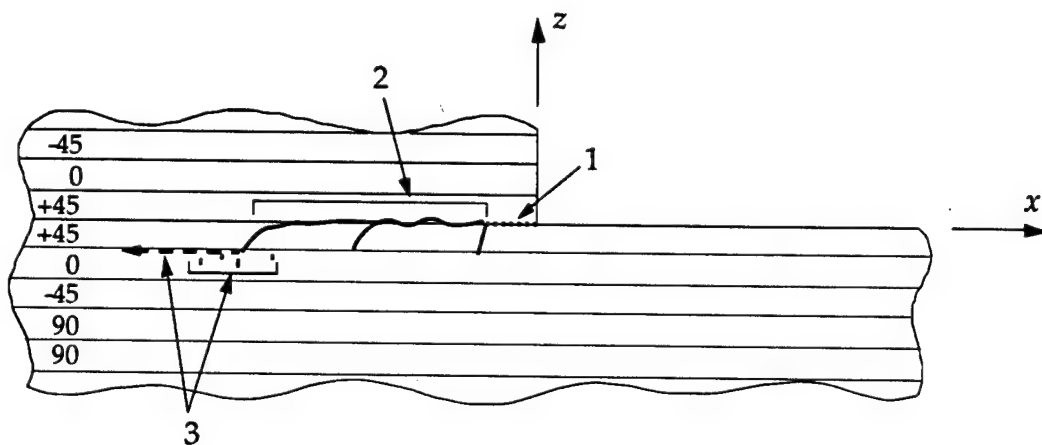
Figure 29. Damage development on the negative edge.

1. $\{M \approx 70\% \text{ of } M_{fn}\}$ The first damage to appear on this edge is a crack on the 45/45 interface. This crack originates from the corner and travels in the $-x$ direction. Unlike case 1 and 4 tests, the delamination here does not usually occur after the appearance of a crack in the 45° ply. The significance of this

point will be discussed later when delamination initiation mechanisms are considered. It should also be noted that in one of the case 2 specimens tested, a significant amount of damage noise was heard before the interface crack appeared on the negative edge. This observation indicates that damage initiation occurred in the interior of this specimen.

2. $\{M \approx 70\% - 90\% \text{ of } M_{fn}\}$ As the load increases, the delamination propagates along the 45/45 interface as discussed previously for case 1 and 4 specimens: The crack propagates along the interface, turns into the 45° plate interface ply, then resumes its propagation along the interface. As before, this process is repeated several times. However, for this lay-up there is no well-defined interface (surface) which separates as the specimen peels apart. Instead the delamination crack tends to wander back and forth more across the 45° plies (Figure 30).
3. $\{M = M_{fn}\}$ Eventually, the delamination moves to the 45/0 interface and causes catastrophic failure. The region where this occurs often contains broken 0° fibers.

It should also be pointed out that the only damage to appear on the negative edge was that associated with the delamination. No cracking was seen at larger values of x in the plate interface ply.

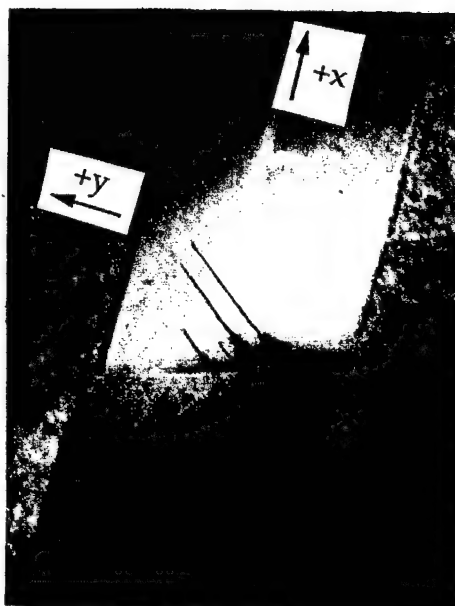
Figure 32.^{en} Penetrant-dye inspection of the plate face.
(a) prior to catastrophic failure. (b) after catastrophic failure.

Several of the case 2 specimens were inspected post-mortem using penetrant dye.[†] The dye was applied to the top face of the plate near the step to learn more about the development of cracking in the 45° plate interface ply. The results of this inspection clearly showed that the cracks were scattered across the width of the specimen near the step. By comparing the cracks in a specimen that was not tested to catastrophic failure (Figure 32a) to one which had failed (Figure 32b), one can see that the cracks become more numerous as the test progresses. Also, inspection of one specimen which was tested only to

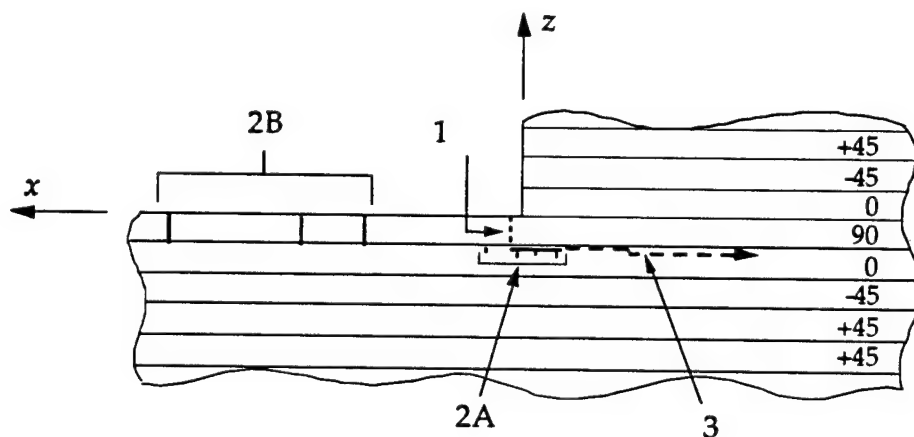
Figure 33. Damage development on the positive edge.

Each level of damage development seen on the positive edge is illustrated in Figure 33 and described in the steps which follow.

1. $\{M \approx 45\% \text{ of } M_{fp}\}$ As in the case 1 and 4 tests, the damage process begins with a crack in the 90° ply near the step. However, for this lay-up the crack tends to be located closer to the corner (on average, about $\frac{1}{4}$ of a ply thickness from the corner).
2. $\{M \approx 95\% \text{ of } M_{fp}\}$ At sufficiently high local loading, the corner crack turns in the $-x$ direction and propagates stably along the interface. As this happens, several fractures appear in the nearby 0° fibers ("2A" in Figure 33).

At approximately the same loading, additional cracking develops in the plate interface ply at larger values of x ("2B" in Figure 33). However, at no point in the test do these cracks appear more severe than the damage by the corner.
